December 28, 2015

Re: Revised Work Plan for Rock Placement on the Time Critical Removal Action
Armored Cap, San Jacinto River Waste Pits Superfund Site, Channelview, Texas

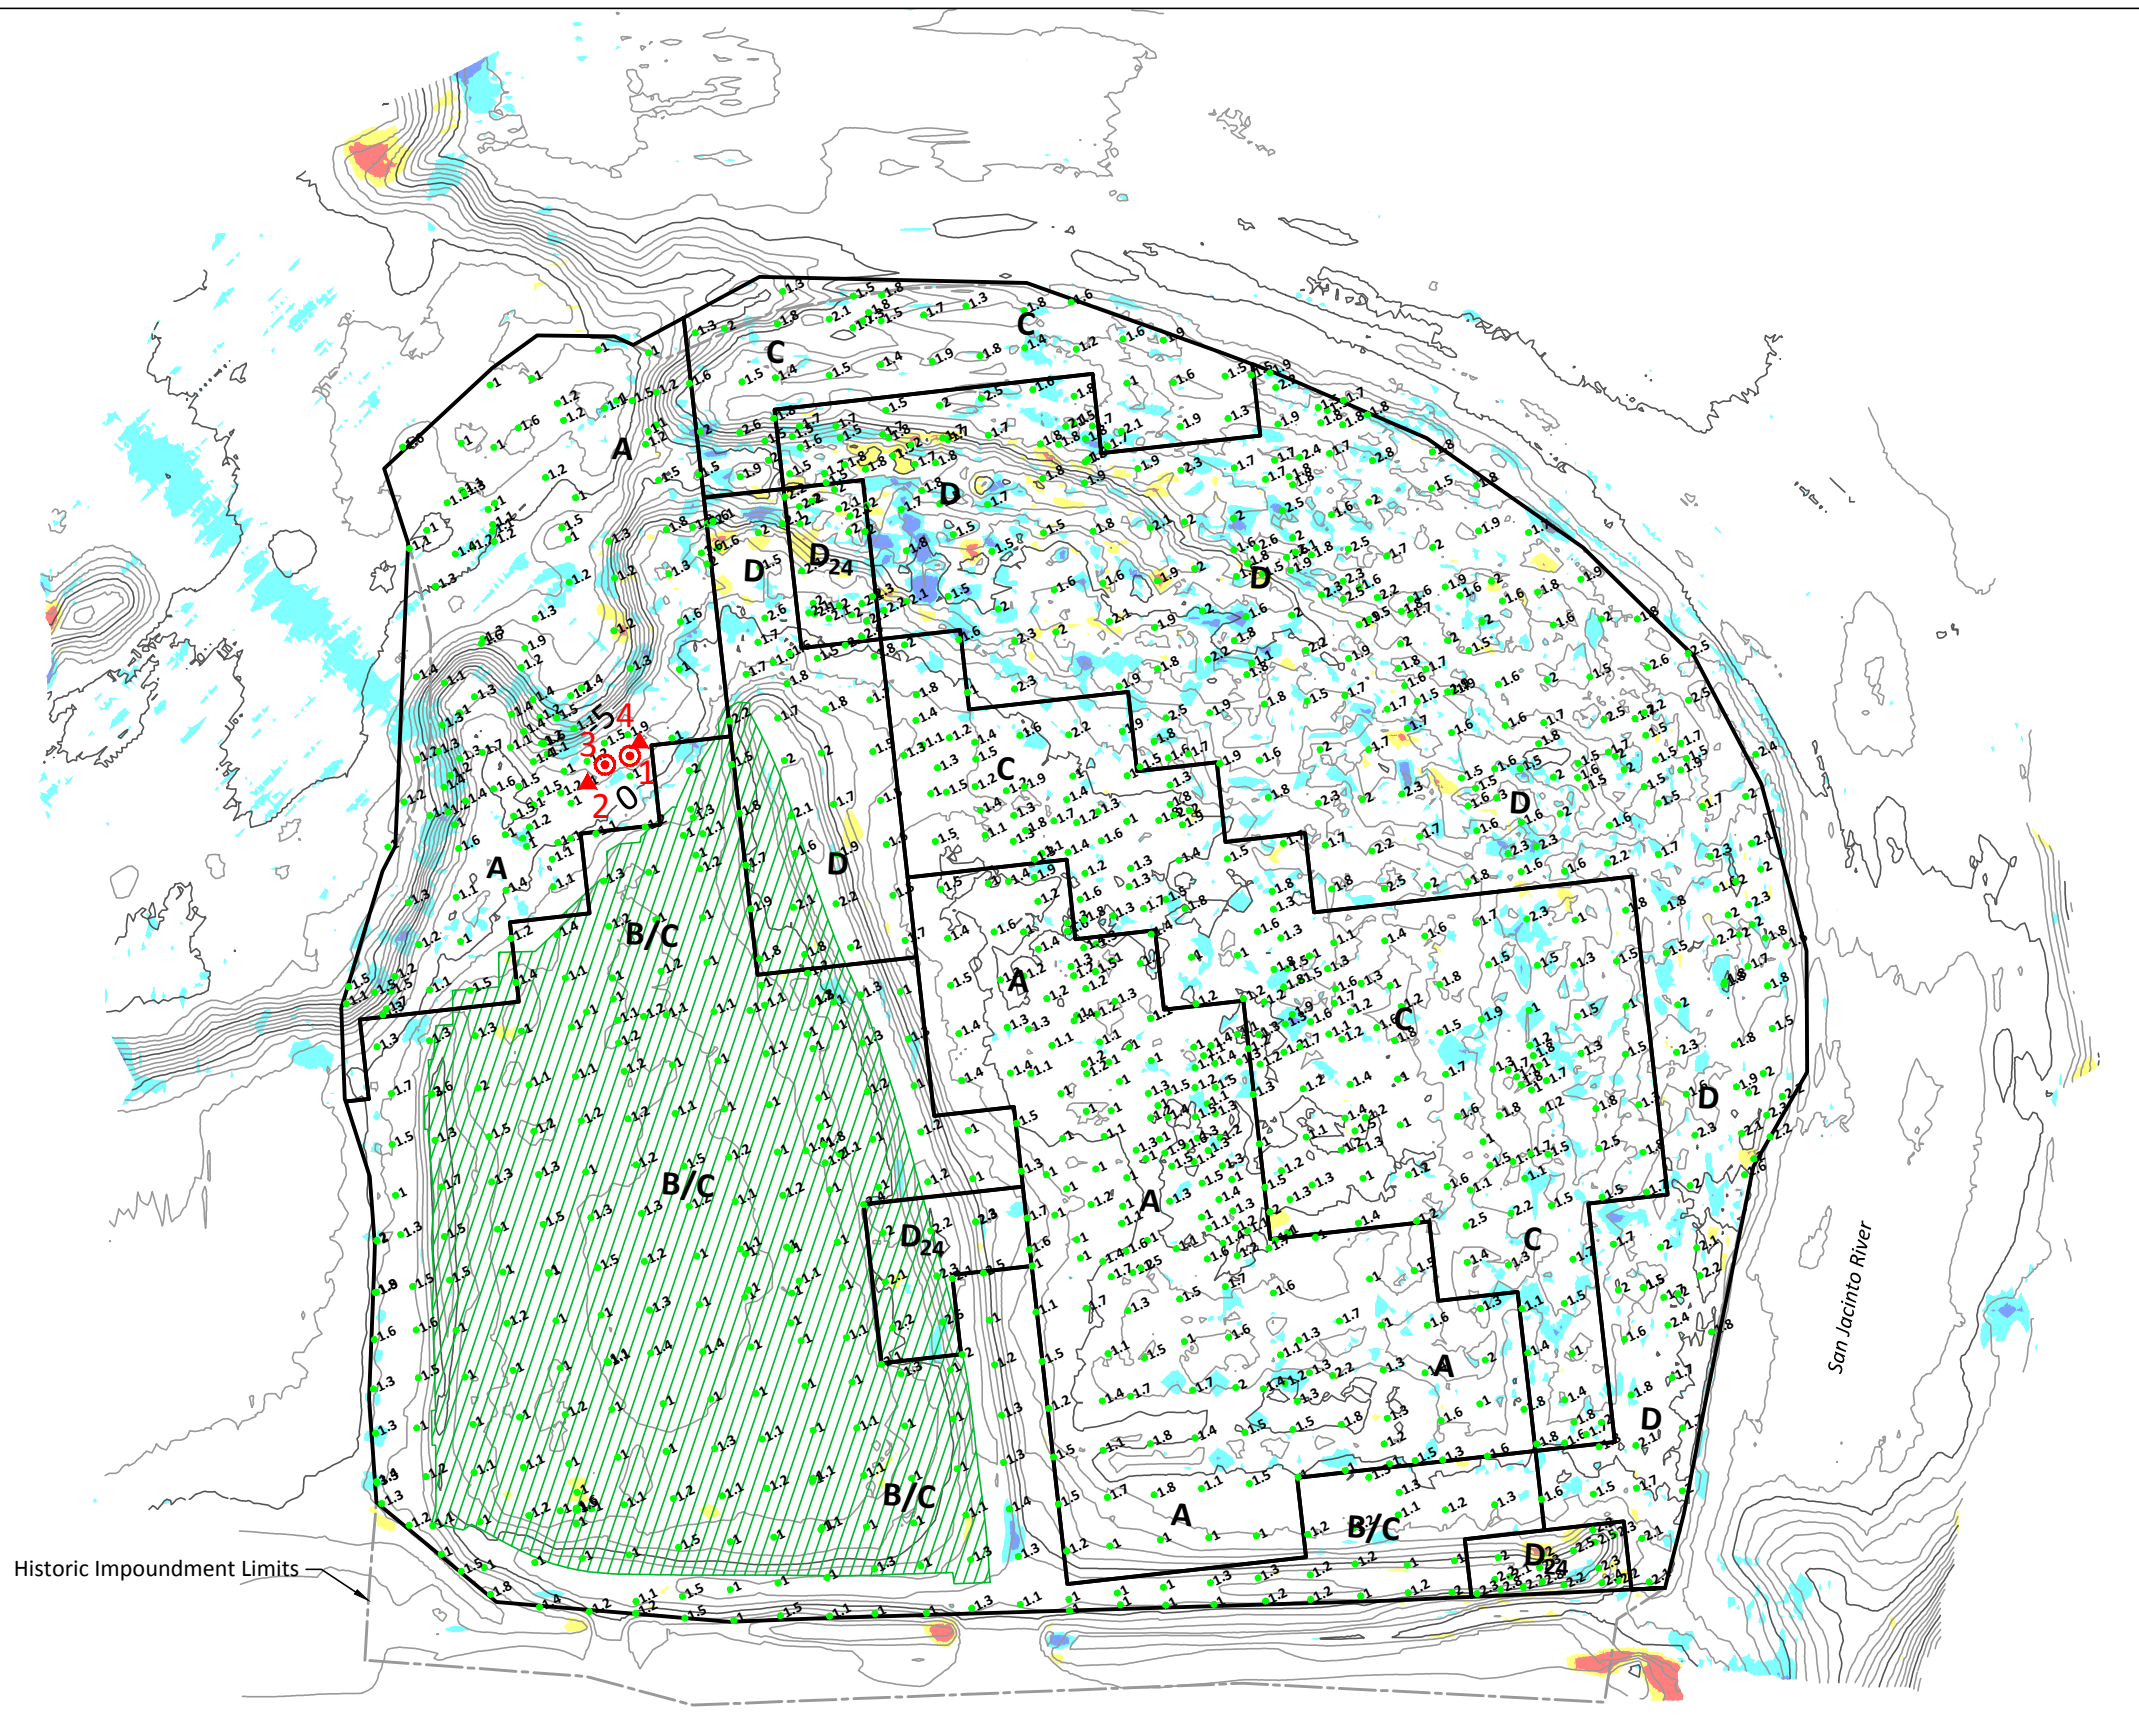
As part of the Time Critical Removal Action (TCRA) at the San Jacinto River Waste Pits Superfund Site (Site), an armored cap was constructed adjacent to the San Jacinto River north of the Interstate 10 (I-10) bridge. The USEPA performed an underwater inspection of the armored cap on December 9 and 10, 2015, and identified an area on the northwestern part of the cap that requires placement of additional cap material (Figure 1).

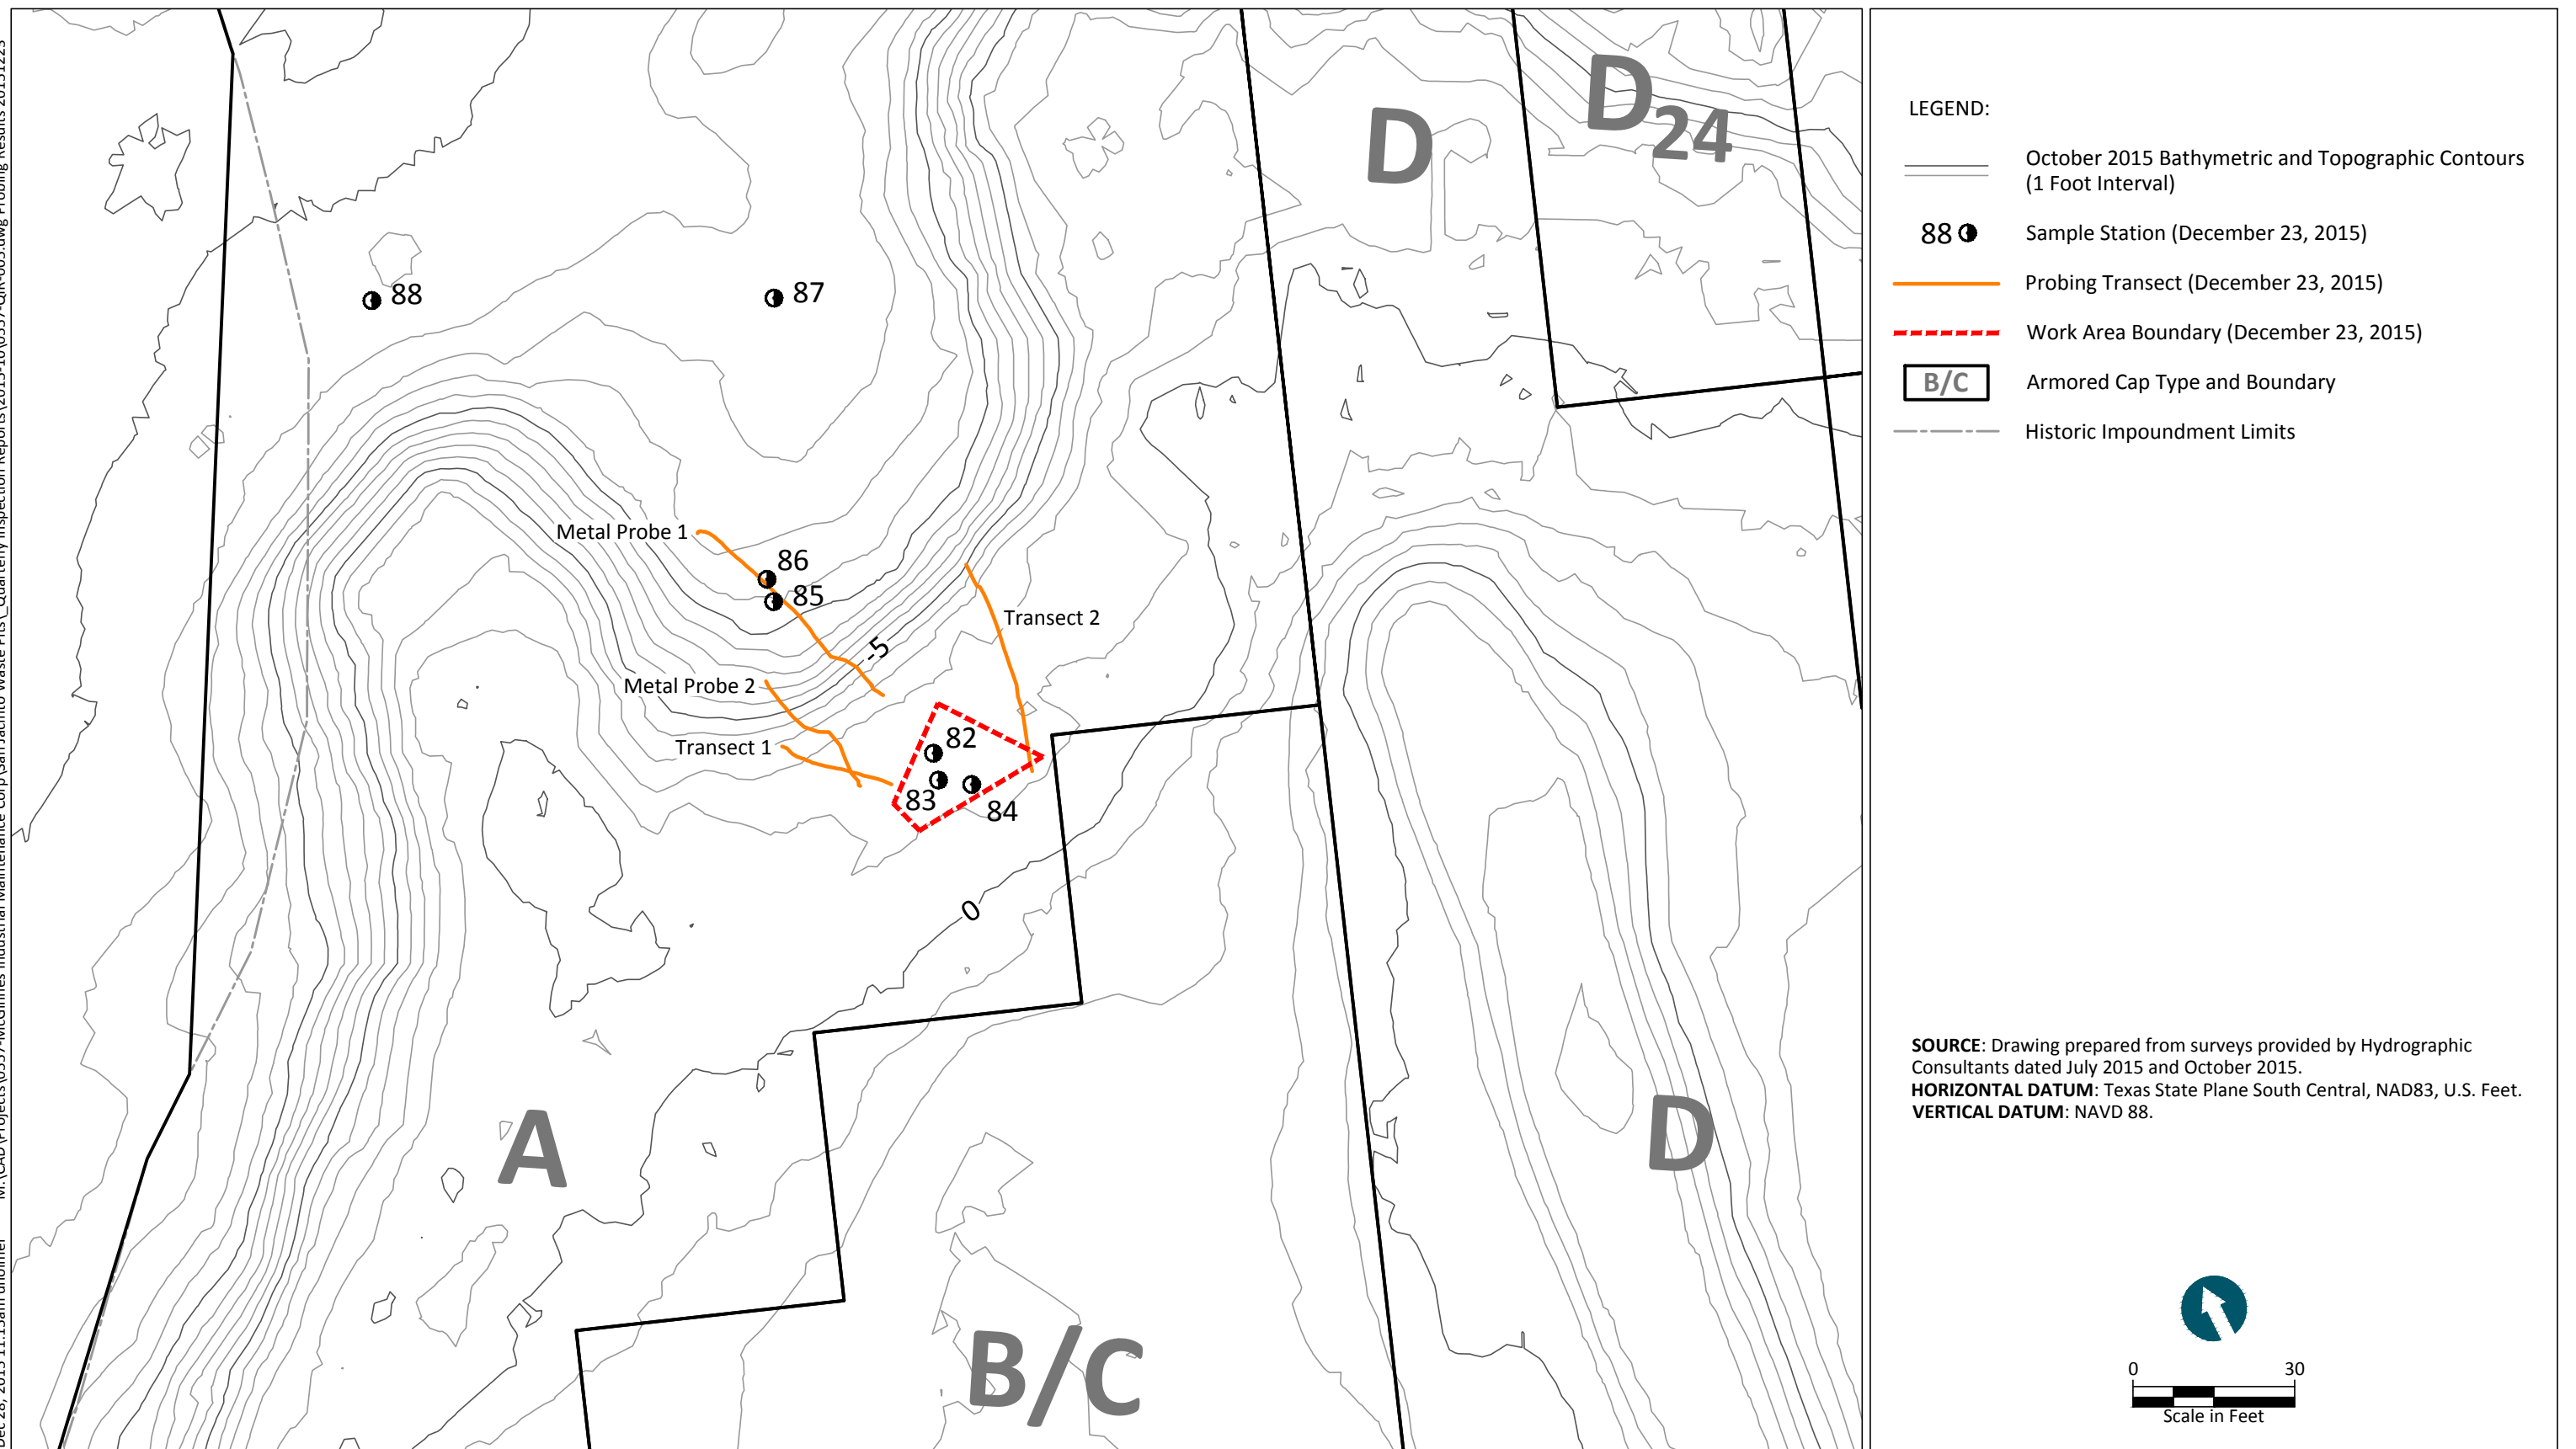
As outlined in the Draft Work Plan, probing was conducted to delineate the Work Area on December 23, 2015. Probes were advanced at approximately 5-foot intervals along a series of transects to determine any locations in which cap material could not be identified as being present at the TCRA design minimum thickness of 1 foot. Per your directive, additional probing was conducted outside of the Work Area along, and at the toe, of the submerged slope for any indication of a buildup of armor rock at the bottom of the slope (Figure 2).

The probing and sediment sampling during the delineation of the Work Area indicated that armored rock was present over the entire area; however, the cap material was intermixed with shells and soft sediment. The Work Area, shown in Figure 2, measured approximately 20 feet by 22 feet and was on the shelf above the slope that exists in the northwestern part of the armored cap. The water depth in the Work Area was approximately 8 to 18 inches at the time of the delineation and sampling. Areas outside of the Work Area were found to be a solid substrate of armor rock and shells that acted to bind the armor material together,

making probe penetration difficult. There was not any indication of build-up of armor rock at the toe of the slope outside of the Work Area.

Because of the amount of cap material and the relatively large size of those materials, it was difficult to collect sediment samples within the Work Area; however, three samples were collected within the Work Area after several attempts under your supervision. Probes of the “shelf” between the damaged area and the slope showed that the area did not have a sediment accumulation that could be sampled. With your concurrence, four additional samples were taken from soft sediment accumulations on top of the armored cap material at the base of the slope below the damaged area and then further north (Figure 2).

The Work Area is a relatively level area located on the shelf above a submerged slope and is set back approximately 15 feet from the top of the slope (Figure 2). Geotextile will be placed using procedures similar to those used during the original cap construction. Because the Work Area is relatively level, the geotextile and armor rock can be placed directly over the Work Area without the use of gravel filter material. As stated previously, the Work Area is relatively level, so construction techniques, such as placement of gravel filter material, and placing armor rock from the bottom up the slope are not required. Geotextile will be initially placed to provide complete coverage between the corner survey stakes that were placed as part of the Work Area delineation. These stakes will provide a visual reference above the water line that will allow the contractor to place the geotextile and armor rock
